CANTER TD

FG6-106 4 X 4

Chassis Breaking

Customer “ Ride Wild Tours”

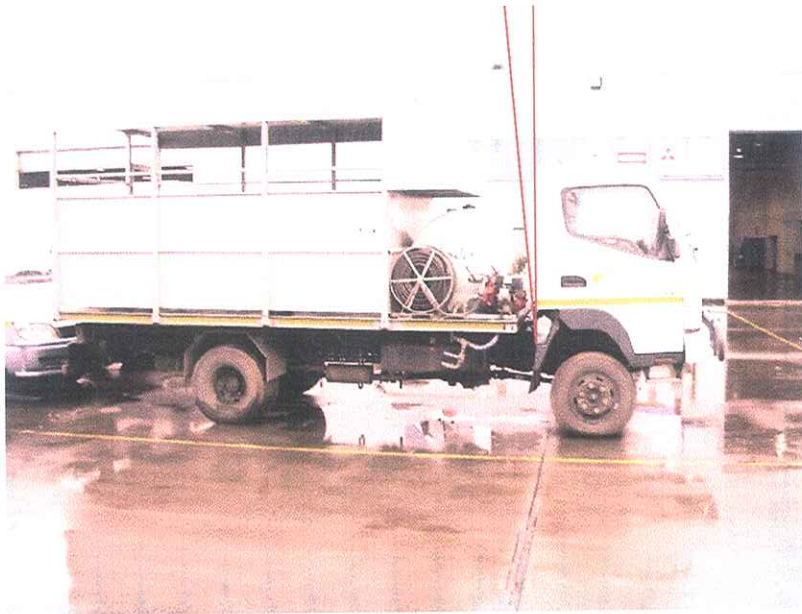
Cab leaning backwards

- Customer’s Vehicle brought in to the dealer.
- Notice how the cab is leaning backwards.

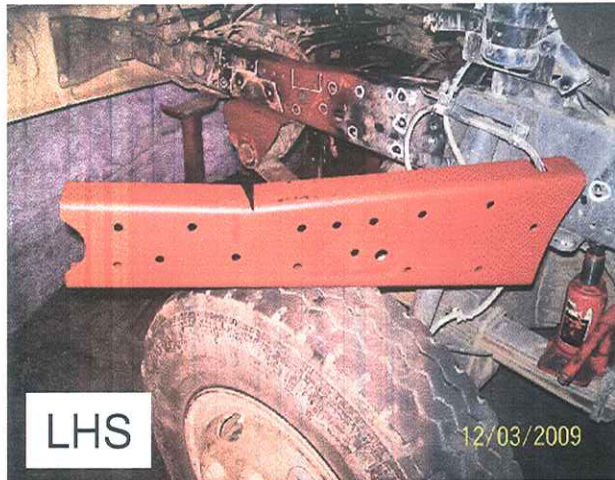
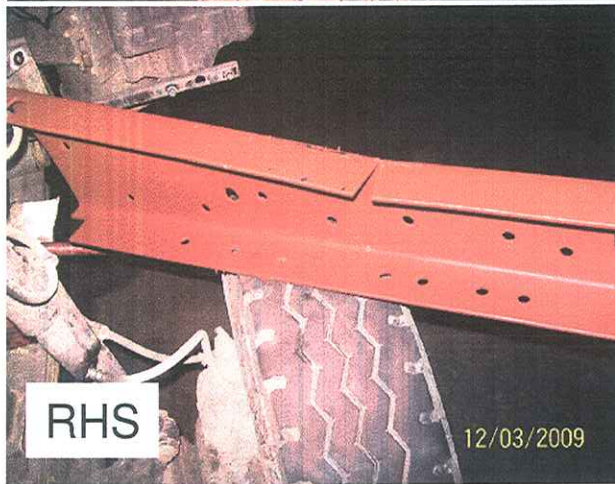
New Pre-fabricated support brackets

- Each hole in the support bracket is utilised either with a fastener, or routing for a cable / brake pipe.
- Support bracket fits over the outer side of the longmembers.
- Inner side of chassis longmembers has already supplied welded nuts to accommodate the additional high tensile bolts to fasten the support brkts.

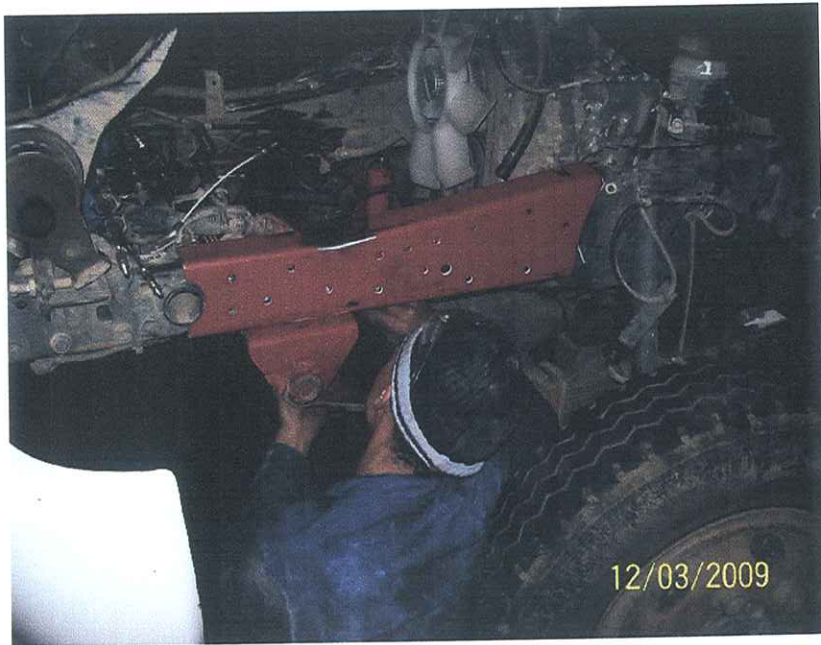
Fitting the Supports to Longmembers

- The unmodified front spring shackle is removed from the frame.
- The support brackets are then tapped into position over the outer sides of the longmember where the frame breaks.
